# At The Conference™...No Extensor Tendon, Now What?

Richard Buch, MD

## Journal of Orthopaedic Experience & Innovation

From the Disasterplasty 2025 Annual Meeting.

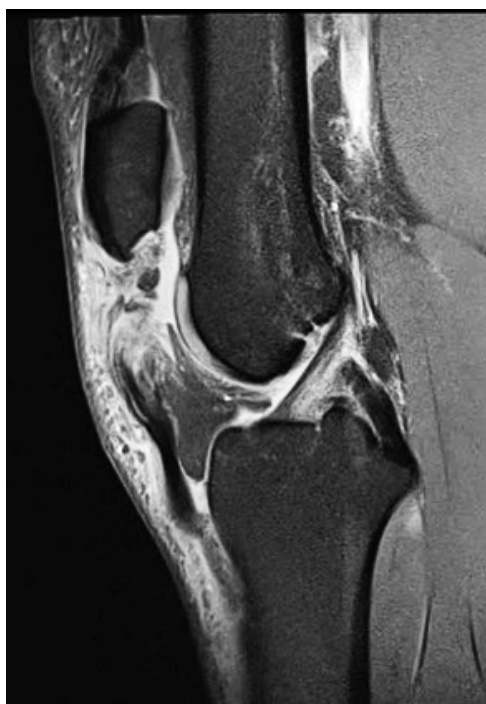
**Figure 1.**

Patellar tendon rupture is a devastating injury and occurs in approximately one per 100,000 knees (for any reason). (Figure 1) Following primary total knee arthroplasty (TKA), patellar tendon rupture approaches an incidence of 2.5%, and > 5.0% following revision TKA (Vaishya et al. 2016).

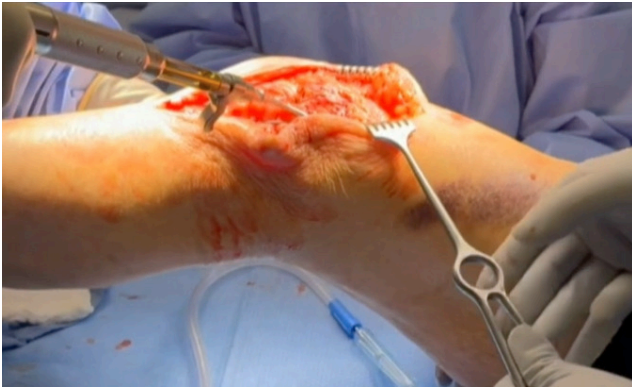
Figure 7.

But how much do you tighten it? Tighten enough when let go against gravity the knee bends between 30 to 45 degrees. (Figure 7) This will allow good tendon repair protection so that they will stretch the quad out over time, and most of them achieve 90 degrees or more.

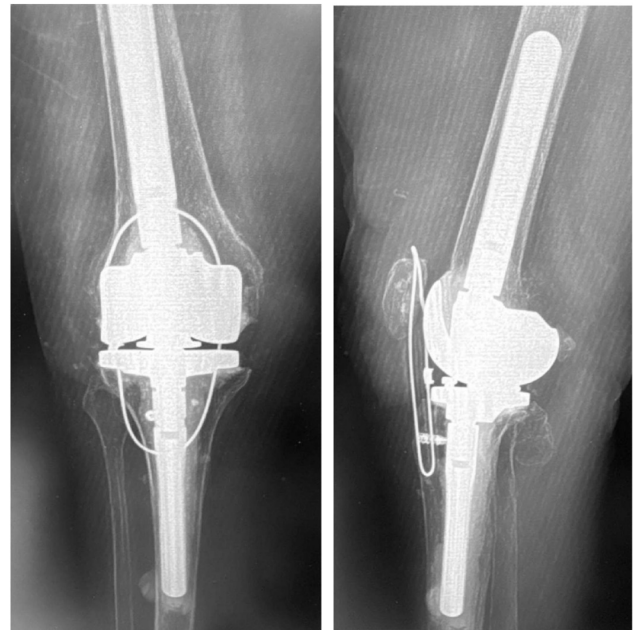
Figure 8.

This is 74-year-old female, with a BMI of 33 kg/cm<sup>2</sup>, and multiple comorbidities (CHF, Arrhythmia, anxiety, 3 previous surgeries of the knee). She presented three months status post patellar tendon rupture, patellar fracture and dislocation. The patellar fracture was fixed with a wire, and in the radiograph you can see the anchor suture in the tibial tubercle area, the wire below the tubercle, within the gutters, and threaded above the patella. (Figure 8)
